TEST REPORT

Cable Gland

AG-25

TEST REPORT IEC60529 Degrees of protection provided by enclosure(IP code)	
Report Reference No.....	NST/GW131423-2-S
Compiled by.....	Cai Qinghong
Checked by.....	Zhu Ningfeng
Approved by.....	He Peng
Date of issue.....	2013-08-02
	Signature: <i>Cai Qinghong</i> Signature: <i>Zhu Ningfeng</i> Signature: <i>He Peng</i>
Testing Laboratory	 
Laboratory.....	Zhejiang Joysun Testing Technical Services Co., Ltd.
Address.....	No.5-9, Zhufeng Road, Ningbo Export Processing Zone, Ningbo China
Tel.....	086-0574-86813875
Fax.....	086-0574-86813876
Client	
Client Name.....	Shanghai Richeng Electronic Co., Ltd.
Address.....	Xinsheng Industrial AREA, Zhelin, Fengxian, Shanghai
Manufacturer.....	Shanghai Richeng Electronic Co., Ltd.
Address.....	Xinsheng Industrial AREA, Zhelin, Fengxian, Shanghai
Test specification:	
Standard.....	IEC 60529:2001
Test procedure.....	—
Non-standard test method.....	—
Test item description	
Sample Name.....	Cable Gland

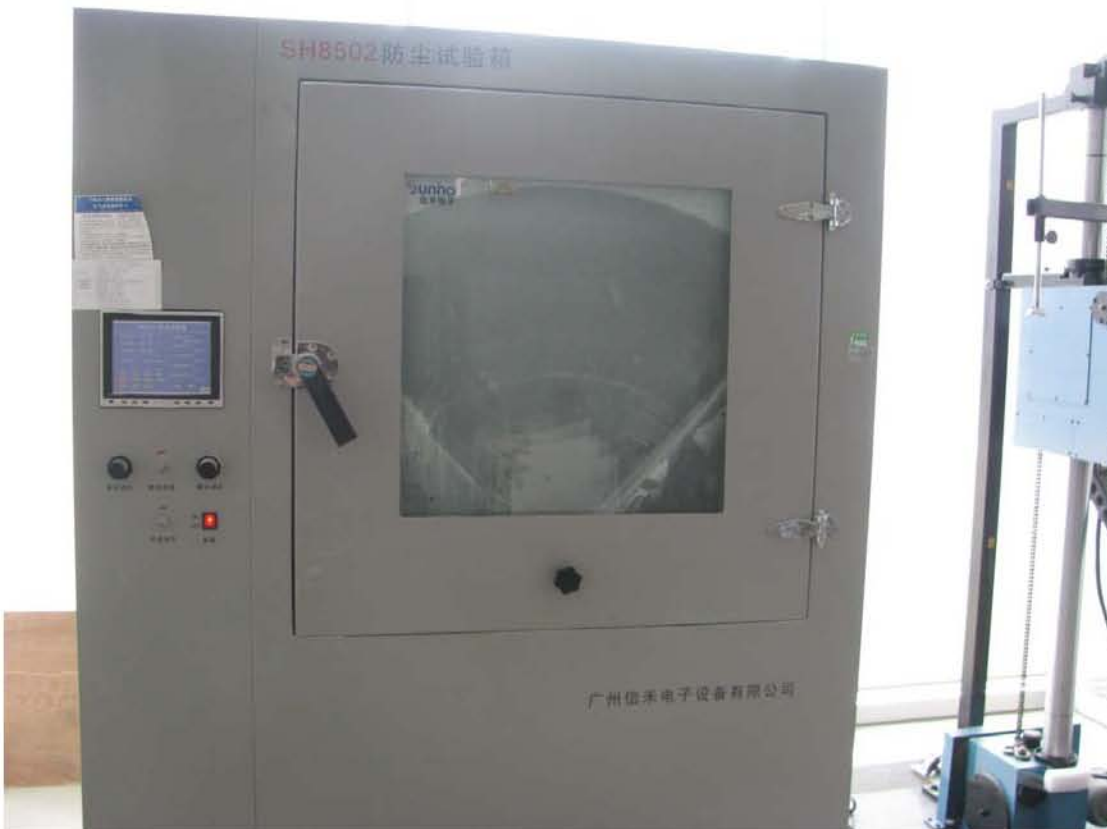
Photograph:

Standard:	IEC60529:2001
IP code:	IP68
Operating conditions:	IP6X: The object is freely suspended in the dust chamber, lasted 8 hours with the depression not exceed 2KPa, the pressure inside the enclosure is maintained below the surrounding atmospheric pressure by a vaccum pump.
Phenomenon(after the test):	IP6X: No deposit of dust is observable inside the sample at the end of the test. So the protection is satisfactory.

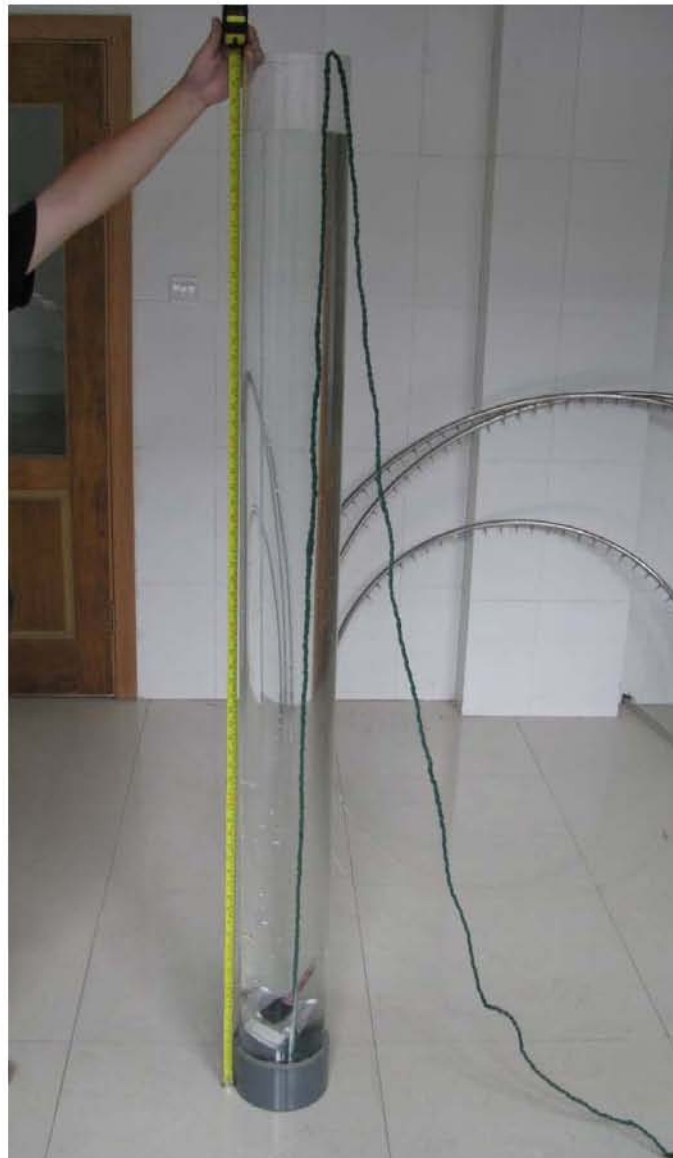
Operating conditions: IPX8: The lowest point of enclosures is located 1.5m below the surface of the water, the duration of the test is 35min; the water temperature does not differ from that of the equipment by more than 5K.

Phenomenon(after the test): IPX8: No water entered.

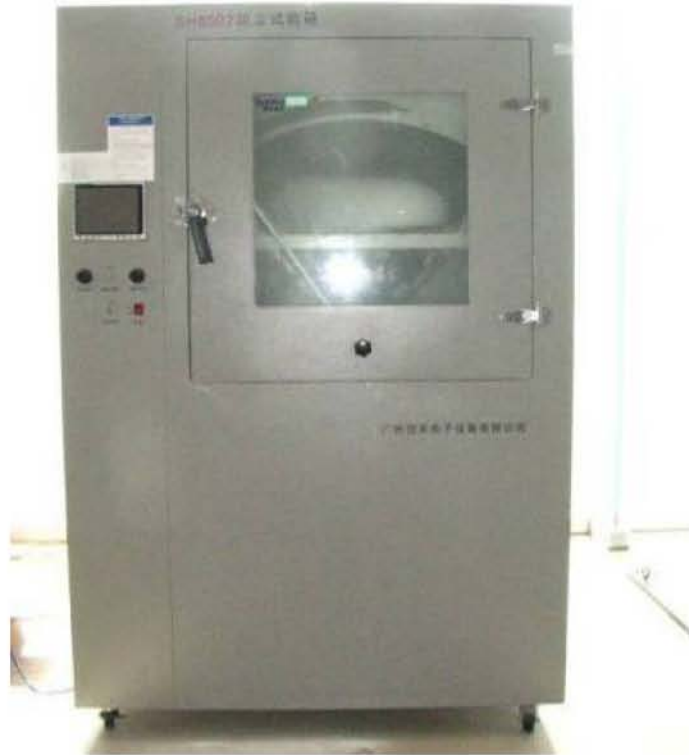
Fig.1 Dust chamber

- 1. Test equipments: Dust chamber (see Fig. 1), Immersiom test device(see Fig. 2),
- 2. Temperature: 22.5℃ Humidity: 70%RH
