No. SHAEC1000863101

SHANGHAI RICHENG ELECTRONICS CO., LTD SHANGHAI OLD HUMIN ROAD CHINA

The following sample(s) was/were submitted and identified on behalf of the clients as: WIRING DUCT

Test Method: With reference to EN 14582: 2007, analysis was performed by Ion Chromatograph (IC).

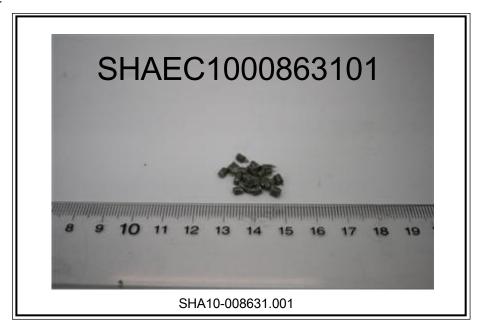
Sample photo:

Specimen No. SGS Sample ID **Description** SHA10-008631.001 Grey plastic
